Home Integrity Inspections

Confidential Inspection Report

**6163 Your Street
San Diego, CA 92101**

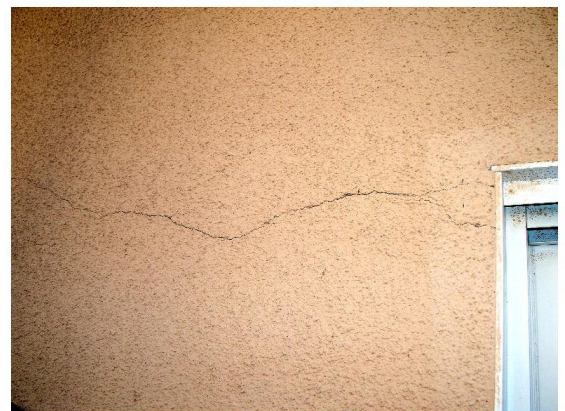
Materials & Condition: Walls are constructed with: Stucco. Several cracks noted are major. Recommend evaluation and repairs to be done by a licensed stucco contractor.

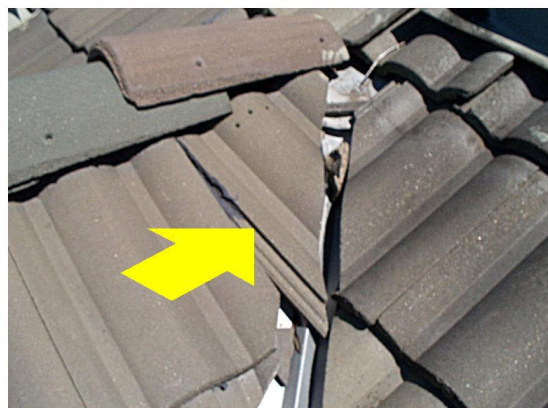
Style:	Hip roof.
Roof Access:	Walked on roof.
Roof Covering:	Acceptable overall. However, there are several loose tiles located at the valleys. Recommend evaluation and repairs be done by a licensed roofing contractor.

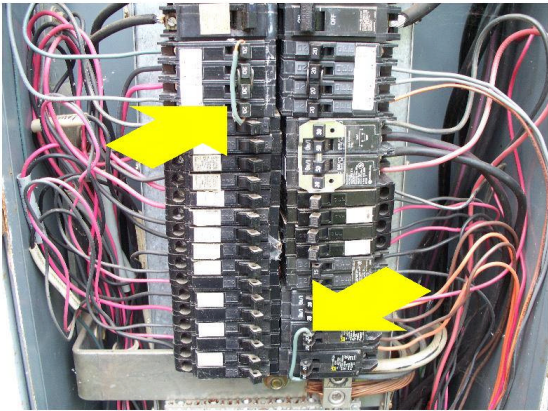
Main Panel Observations: Two 220 volt handle tie(s) are missing. Recommend a licensed electrical contractor install ties as needed.

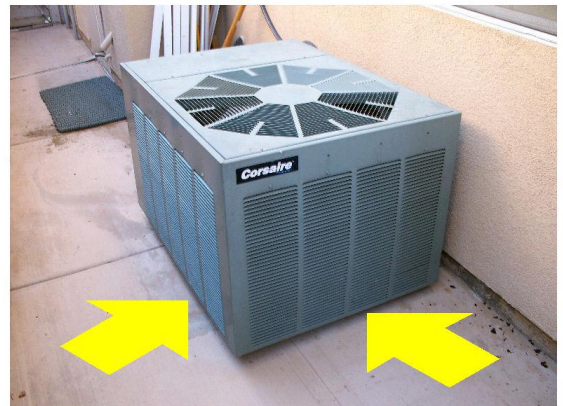
System Condition: Operable. However the condenser should be fastened at its base to the concrete below.

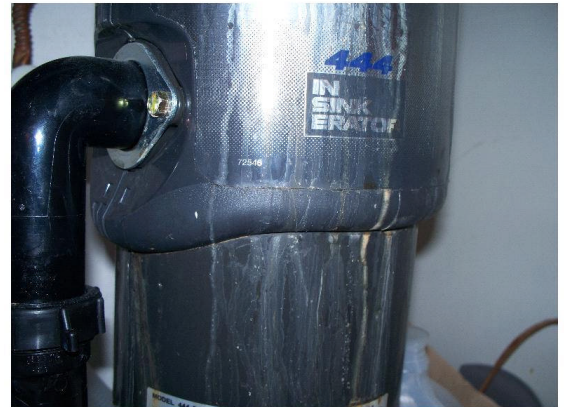
Unit is an older model. Evidence of past leakage noted. Unit may be near the end of its useful life.

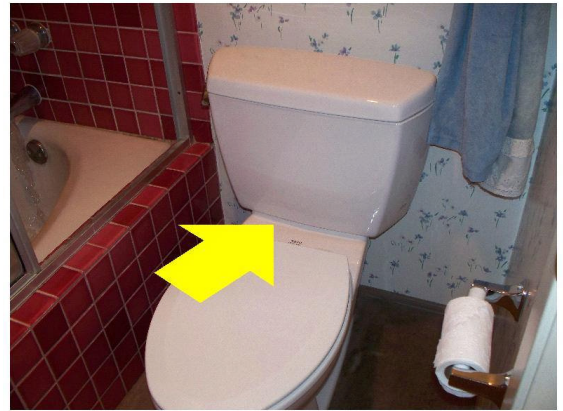
Overall acceptable. However, the tank is loose a its base. Tighten as needed.

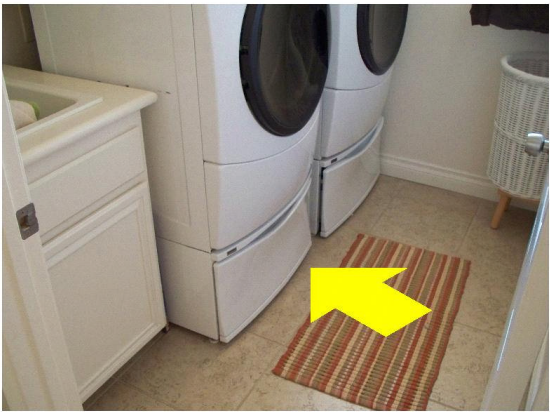
Location:	Hall - 2nd floor.					
	AC	MG	RR	MN	SF	
Fuel System:	p	Gas service
Clothes Washer:	p	
Clothes Dryer:	p	
Dryer Vent:	p	
Floors:	p	Tile.
General Observations:	An overflow pan is not installed. Overflow pans are commonly installed where laundry appliances are located indoors. They are installed for the purpose of controlling any excessive water coming from a washing machine, and to prevent damage to floors, moldings or walls.
